SURRY POWER STATION

Unit One 2001 Reactor Head Inspection and Repair Critique and Lessons Learned

Surry Power Station

Unit one Reactor Head Nozzle Repair

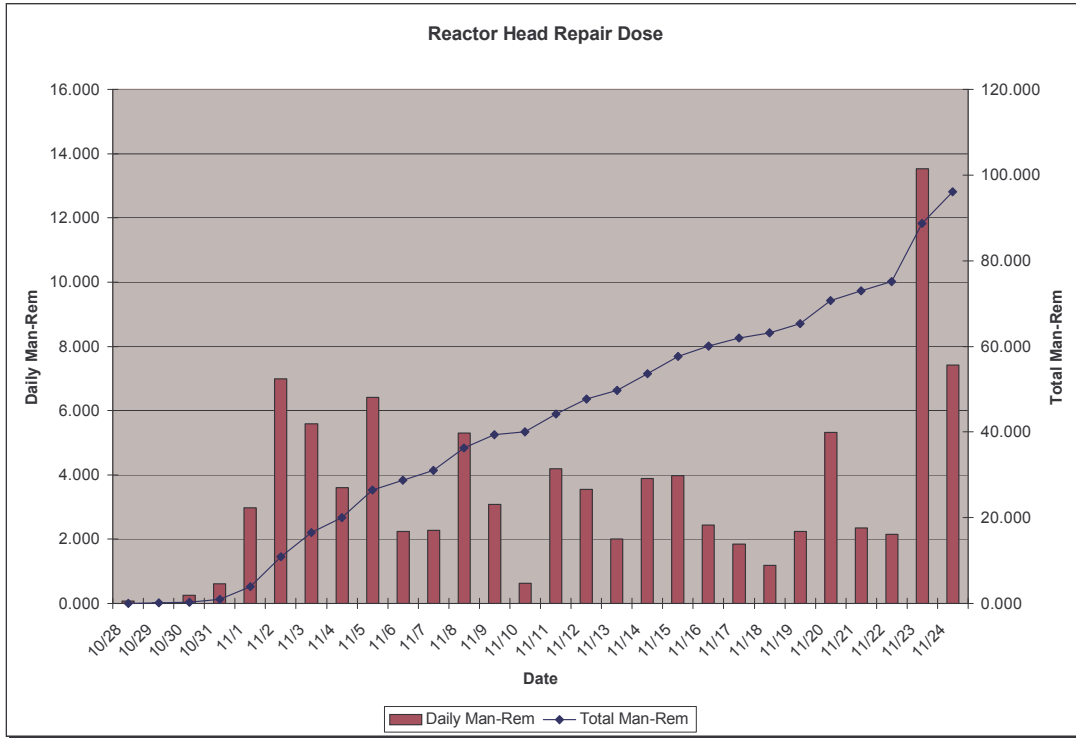
The graphs below detail daily dose and total dose for the repair work.

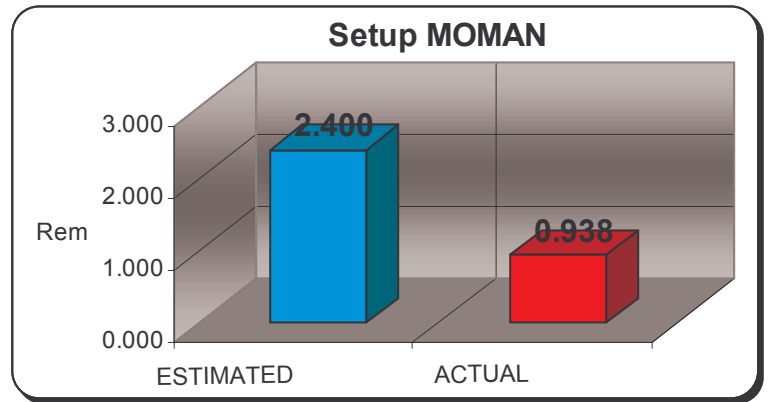
Setup of Moman

While this activity was called Moman Setup, it contains exposure for the entire repair setup. 2.400 person rem was allotted for these activities, while only 0.930 was spent in the setup. Most of the setup was performed outside of the head stand area to reduce exposure.

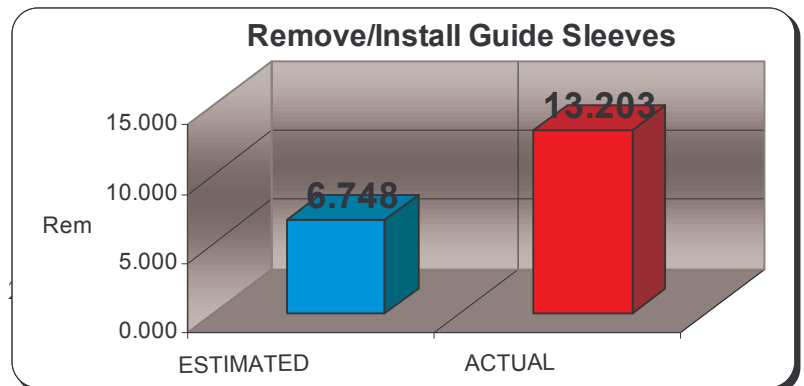
Remove/Install Guide Sleeves

This activity included honing and cutting of the guide sleeves, end prep of the remaining portion of the sleeve in the nozzle, and welding of the new guide sleeve segment in the nozzle. The tools used for the honing and cutting required

maintenance that was not estimated for. Honing of all guide sleeve cut locations and setup on the first cutting location cost 5.882 Rem, or 87% of the estimate for the entire removal and installation process. Once the cutter lodged on the first cut location, dose for cutter removal was tracked under a separate activity. Although the guide sleeve welder worked well, the welding operation cost 7.014 Rem. Also, 0.229 rem was spent prepping the ends of the guide sleeves to allow for good fit-up.

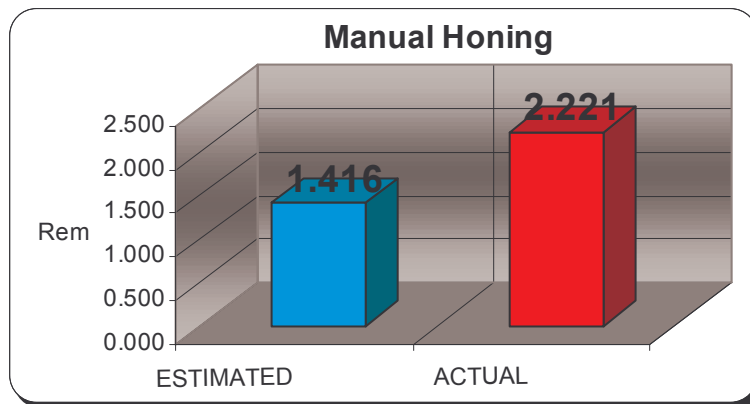
Manual Honing

Once the decision was made to use the EDM process for sleeve removal, the sleeves required honing in the location of the EDM cuts. Since the honing tool could not be set to

the required depth, manual honing was necessary. An extension shaft was used with the manual-honing tool so that the operator could stay on the floor to perform the operation. Honing took longer than expected and cost

2.221 Rem.

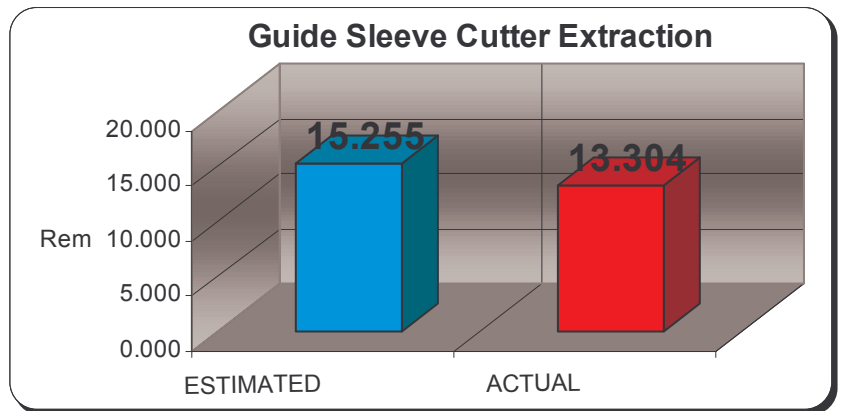
Guide Sleeve Cutter Extraction

This activity was not initially planned, but became necessary once the cutter would not release from the sleeve. Initial attempts to remove the cutter were tracked under the guide sleeve removal/replacement activity but were later moved to the extraction activity when it became apparent that the cutter would not be easily removed. The initial attempt at removal was made by trying to back out the cutter blades and lowering the tool. 2.732 man-rem was expended in this attempt. At this point, the focus was changed from trying to save the tool to removing the tool. Two attempts were made to remove the tool by hammering it down. The first cost 1.150 man-rem and the second expended 0.482 man-rem.

The next removal plan was to jack the tool out. Initially two attempts were made using shims and two porta-powers. This, however, proved to be dose intensive as the workers had to hold the shims in place until the jacks engaged them with the nozzle and the tool. These attempts cost an additional 4.994 man-rem. At this point a jacking tool was designed and built on site. This tool would minimize the number of entries under the head. Mock up

testing and training on the tool further helped in reducing exposure for the next attempts. Also, as a result of the testing, an electric hydraulic pump replaced the manual pumps. This helped in reducing the time required to raise and lower the jacks. The attempt to jack out the tool with the hydraulic jack failed to move it more than 9 inches. While the attempt failed, the planning, testing, and training at the mockup was helpful in keeping crew exposure minimal. 1.774 man-rem was spent in this last attempt.

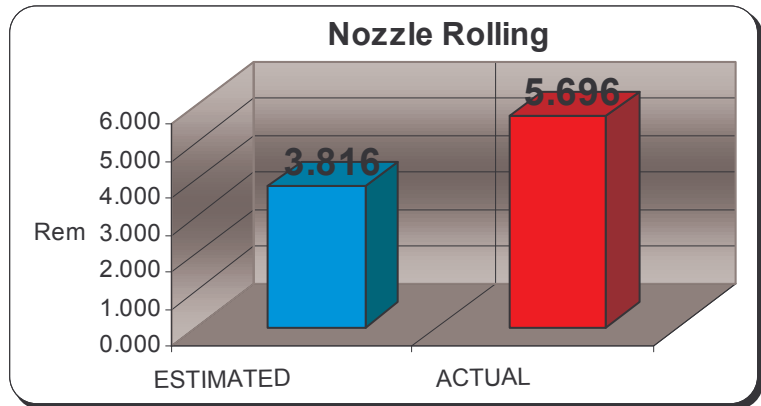
Nozzle Rolling

Nozzle rolling was the first step in the actual nozzle repair process. Initially, all the repair locations were to be rolled prior to any machining, however, after the cutting tool became lodged in location 27, Nozzle 18 was rolled to allow repair work to proceed while the guide sleeves were removed in the other locations. After nozzle 18 was machined, locations 40, 47, 65, and 69 were to be rolled. However, a discrepancy was found between the actual measurements and the repair drawing. This discrepancy affected locations 40, 47, 65, and 69. These locations were rolled at a later date. Location 27 was rolled separately after machining and welding all other locations. While the estimate revisions accounted for the increase in tool change outs, more dose was spent rolling nozzles than what was allotted. In part this was due to measurements taken on the nozzles the night that the discrepancy in measurements was discovered, and in part due to the insertion of FME plugs that were not covered in the estimate.

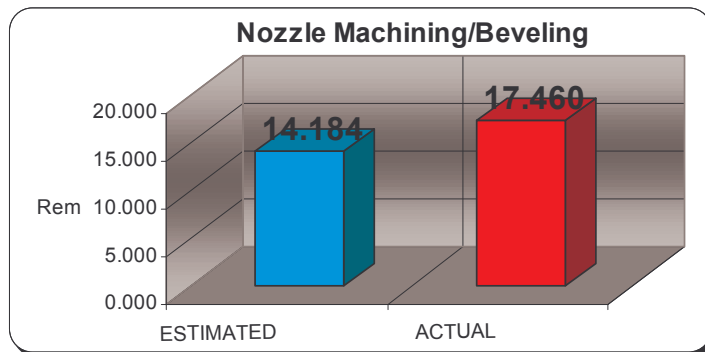
Nozzle Machining and Beveling:

Nozzle machining followed the same sequence as rolling. The increase in tool change outs were factored in to the estimate revisions, however actual dose was greater than the

estimate. Reasons for this include more cutter change outs than anticipated, and equipment

failures. Chips collecting in the MOMEN pulley system caused MOMEN to fail more than once. The machining tool also snapped a pin. A replacement was machined from a stronger material. The failure of the machining tool and the time it took for the repair prompted the change over to rolling. The swap out from machining to rolling and back to machining increased the dose for the Machining evolution.

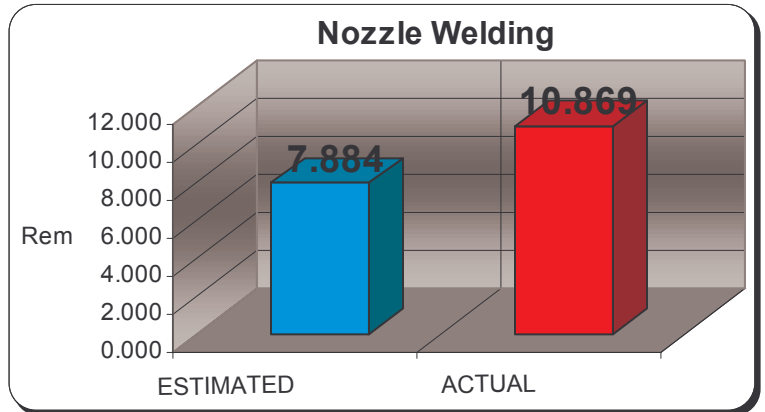
Nozzle Welding

The welding task exceeded the dose estimate. While the change in sequence is responsible for some of the increase, tool failure and repair were also responsible. Tungsten change outs were also underestimated. The first nozzle alone accounted for the number of change outs for all the nozzles. Also, the wire change outs were not estimated for in this activity.

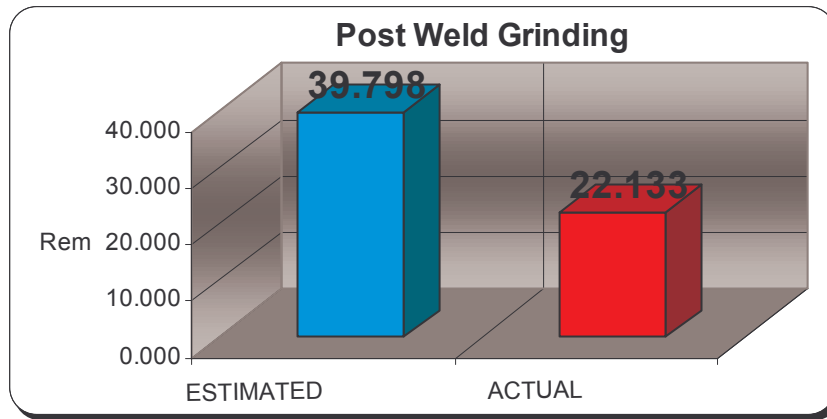
Post Weld Grinding

Post weld grinding included both the machine grinding of the weld and the chamfer grinding of the old weld. All welds were machined ground in

sequence, so the only entries made under the head were to move to a new location and to change grind stones on the cutter head. No mechanical problems were experienced with the equipment but refurbishment was required. This work was performed in the basement of containment for 1.136 man-rem.

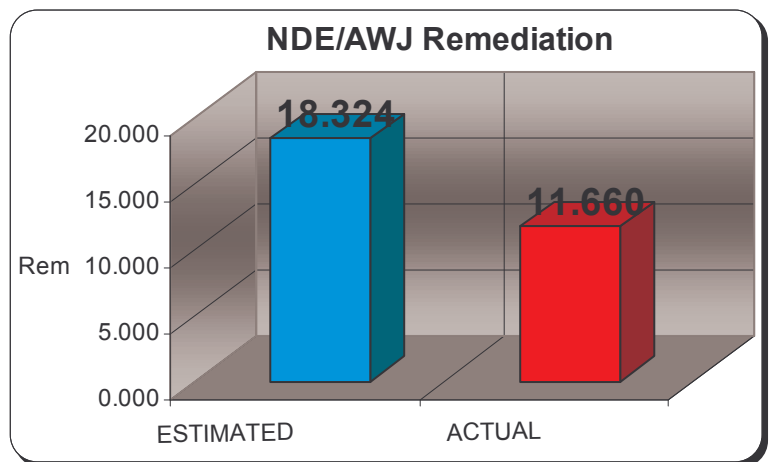
Post Weld Grinding

The NDE portion of this activity included the final PT and the UT of the weld. The PTs were performed by hand and required multiple entries under the head. The UT was performed using a Framatome ANP designed tool that was attached to MOMEN and delivered a UT probe to the region of interest. UT was accomplished in about 9 hours at a cost of 3.755 man-rem. Penetrant Testing of the nozzles cost 2.858 of the total dose received for this activity. The Abrasive Water Jet (AWJ) remediation accounted for the rest of the dose or 5.057 man-rem. There was 8.730 man-rem estimated for the AWJ process. The AWJ tooling required extensive work both before use, and during remediation. While most of the repair was performed in the lower dose of the basement

and the next elevation above, this work accounted for approximately 2 man-Rem in exposure.
