CHALLENGES ENCOUNTERED WITH ELEVATED TRITIUM VALUES

Michael E. Doty
Perry Power Plant
First Energy Nuclear Operating Company
10 Center Rd Perry Oh 44081

2003 RETS-REMP Workshop
June 23, 2003

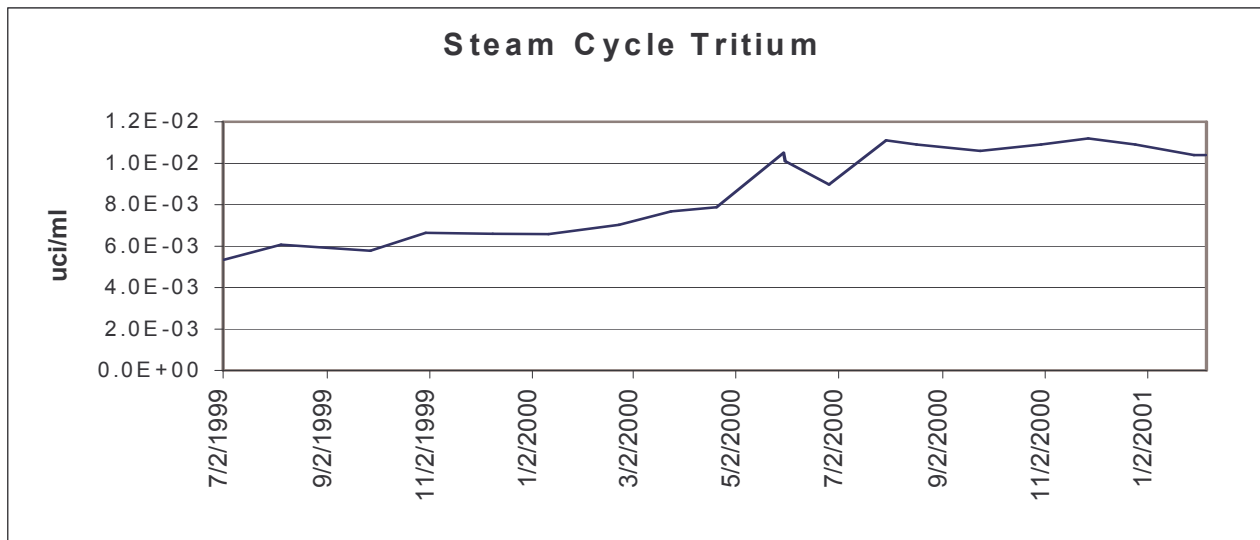
Behavior of tritium observed during previous cycle.

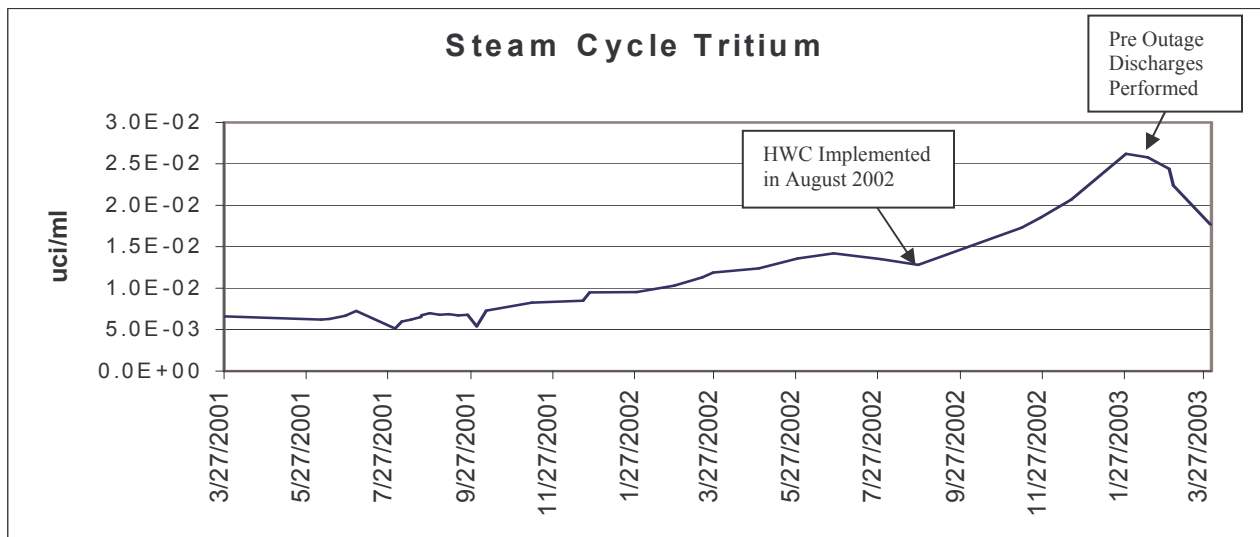
Leakage from control rod blades and a new defect detected late in the cycle caused tritium to rise above equilibrium value.

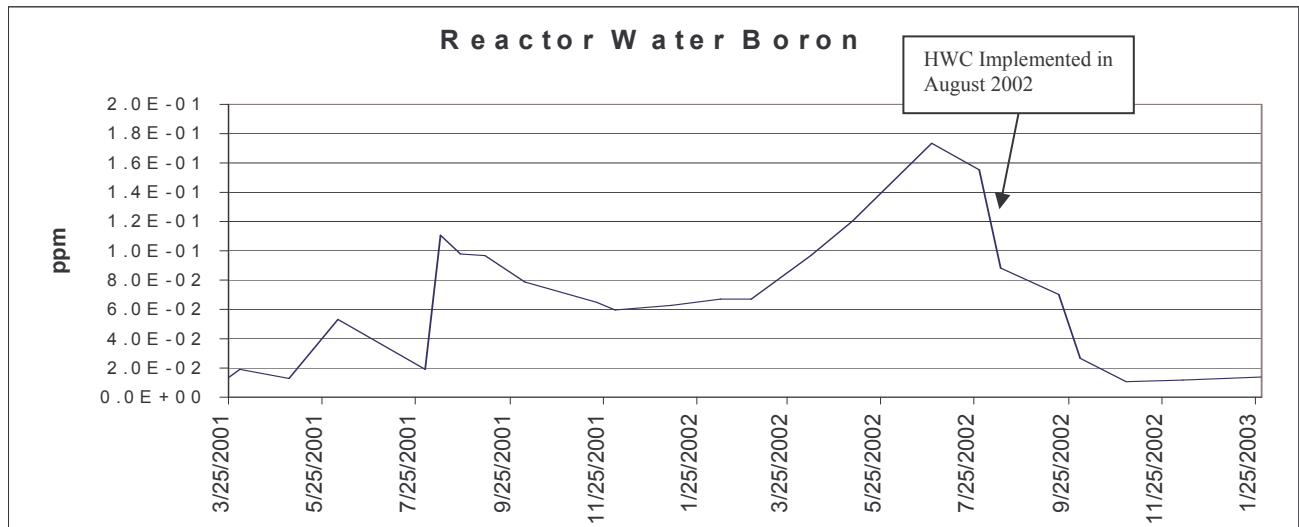
Increases in Reactor Water Boron from control rod blade leakage contributed to the production of tritium. Hydrogen Water Chemistry Program was also started during the month of August 2002. Tritium values continued to rise. A new defect detected in the core helped contribute the increase in tritium.
