RE-ENGINEERED MET SYSTEM

NUMUG
San Francisco, April 1996

Robert Pickwood
Dean Peckham

The Re-engineered Meteorological Data Transmission System (hardware)

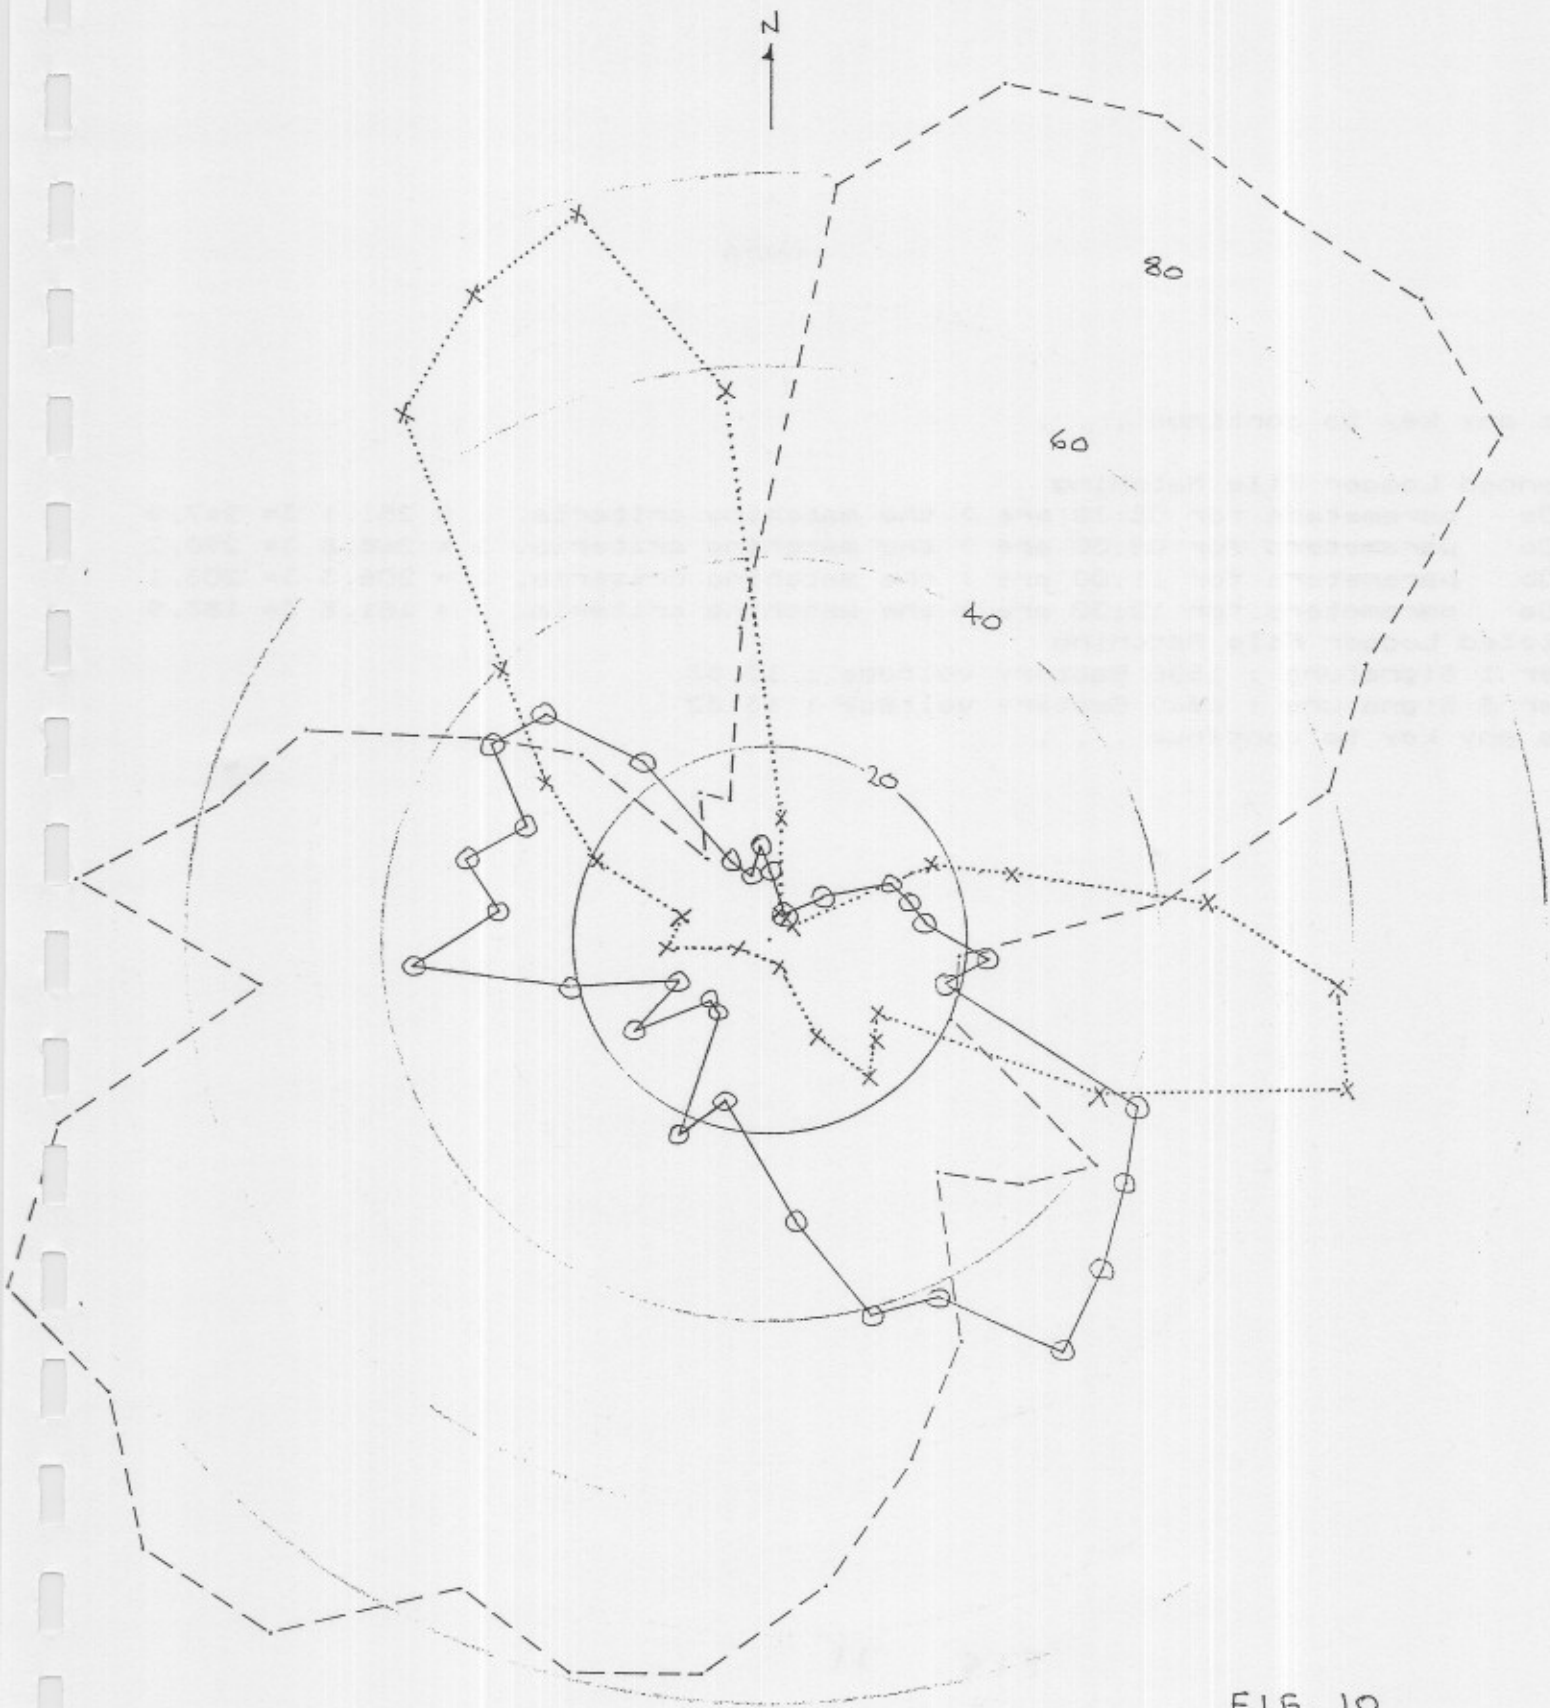
FIG. 10

Percent of Speeds (A-B): negative (x.....x)
 equal (○——○)
 positive (.....)

Another display of speed differences relative to compass values is shown in Figure 10. Redundant speeds were subtracted from primary values. Percents of positive, negative and equal results were plotted for each of the 36 sectors. Equivalence

percentages are highest to the southeast and west-northwest, but do not strongly dominate in those areas. Assuming nearly identical equipment, factors affecting speeds from these two directions must be similar.

Definite redundant speed dominance occurs to speed percentages of the north-northwest and east directions. Though higher redundant speeds of easterly flow comprise 60% of all east winds, averages are only 0.1 mile/hour greater than primary ones. Compared to other directions, east wind components are infrequent. As indicated in Figure 9, redundant speeds from the north-northwest show a large frequency of exceedance over primary speeds. This was expected as average differences are up to eight times greater than the east lobe values.

Percentages of primary speeds exceeding those of the redundant occur with northeast and southwest flow. Poor exposure for the redundant wind sensors would likely explain the high percentages of primary values associated with northeast winds. Somewhat similar exposures exist for the sensors with southwest flow, but for this region primary averages are only 0.1 mile/hour greater, though consistently so. Resultant primary averages during northeast direction cases are as much as 1.3 miles/hour greater.
