EVALUATING METEOROLOGICAL MONITORING SITES USING SIGMA-THETA

by
Kenneth G. Wastrack and Doyle E. Pittman
Tennessee Valley Authority

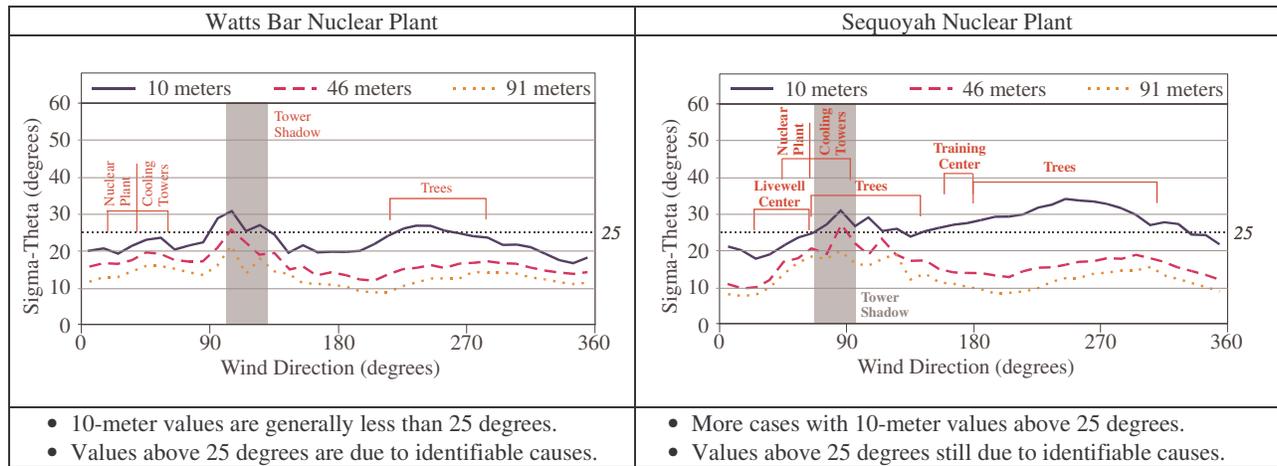
The annual average Sigma-Theta values were plotted on a graph which identifies features and obstructions that were expected to impact the measurements. An arbitrary 25-degree limit was used as a cut-off for analysis.

For both Watts Bar and Sequoyah, the Sigma-Theta curves are generally consistent with the location and type of obstructions. However, for Browns Ferry, there a dip in the 10-meter Sigma-Theta curve for 150-210 degrees that is not consistent with obstructions.

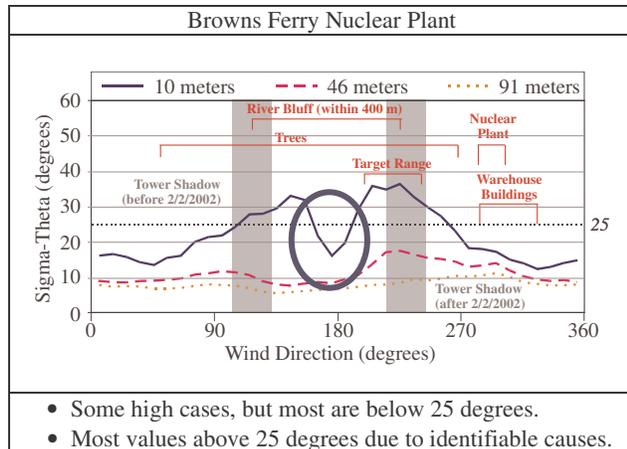
Why is there a dip in 10-meter Sigma-Theta? (Dip is not consistent with obstructions.)

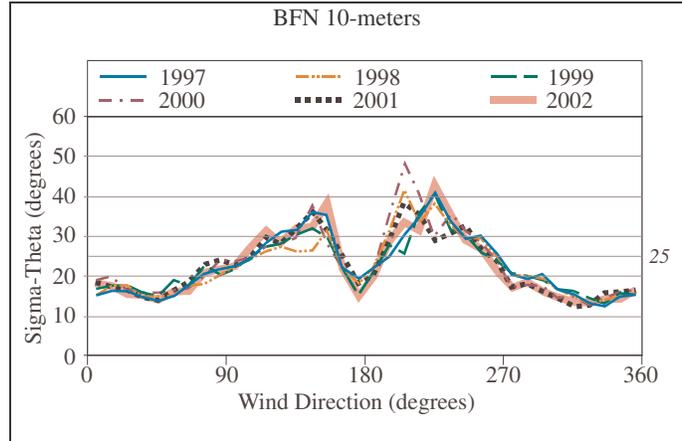
STEP 1—Examine the data on a year-by-year basis to determine if the Sigma-Theta dip is consistent over time or due to a recent change. As can be seen, although there are some differences in other parts of the curve over the years, the dip is extremely consistent.

Therefore, the dip is likely due to a persistent feature of the meteorological monitoring site and not a transient condition.

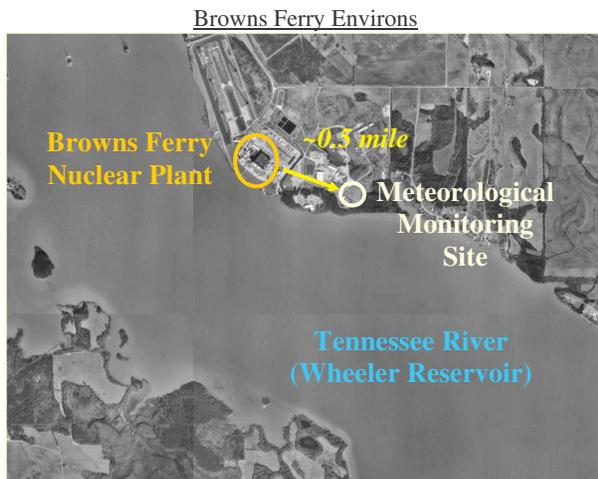
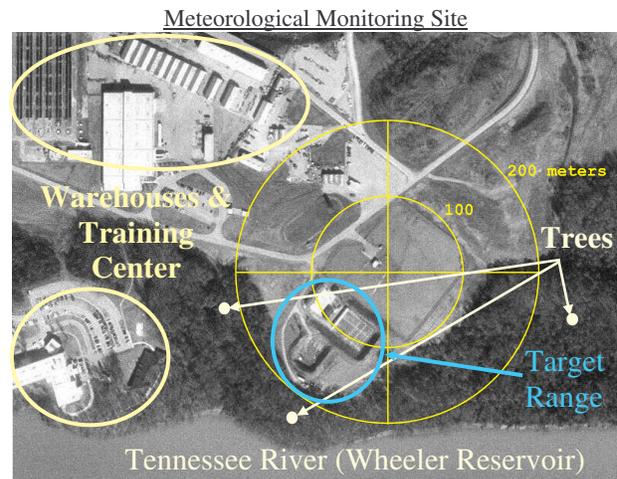
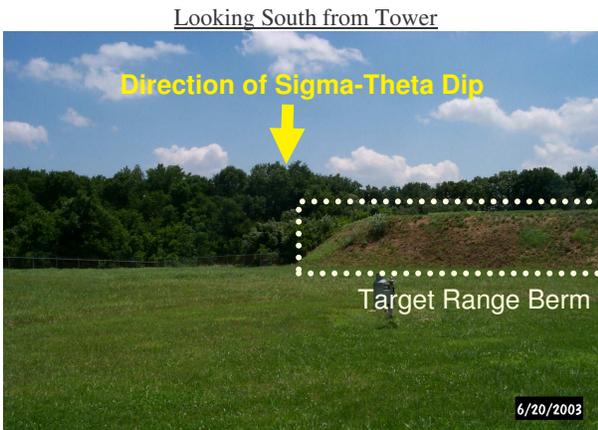
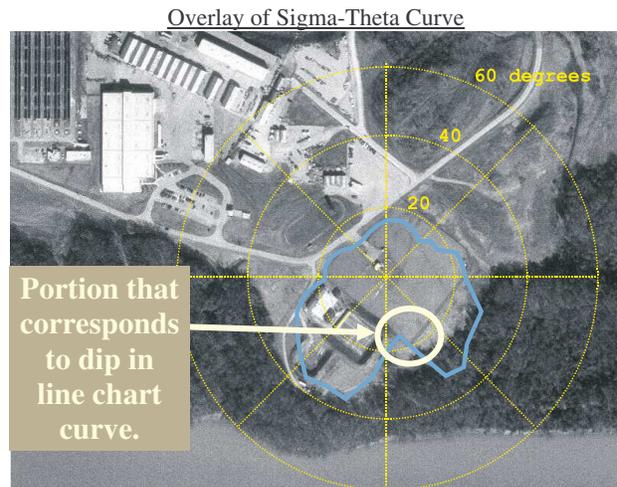
STEP 2—Examine the plant environs and monitoring site vicinity to attempt identification of relevant characteristics.

STEP 3—Based on an examination of the visual information, the reason for dip in Sigma-Theta curve is not apparent. Since a number of changes have occurred that might impact sigma measurements (Table 2), it is necessary to determine if the dip in curve has always existed, and if not, when the change occurred.

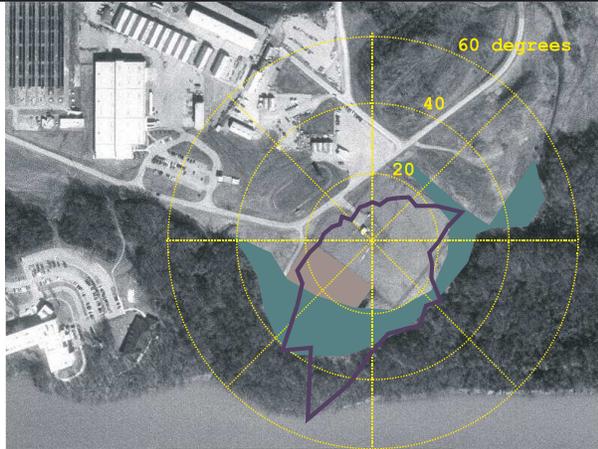
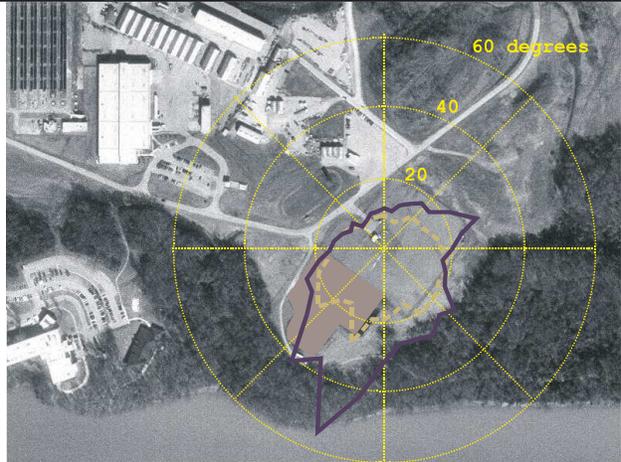
Clear trees to meet 1:10 height criteria.

— Before Trees Cut (1977- Sigma-Y)

— Before Trees Cut (1977- Sigma-Y)
 - - - - After Trees Cut (1978 - Sigma-Y)

- [1977-1978] Changes in Sigma-Y after trees are cut shows general improvement but does not indicate dip.
- [1989-1993] Dip is not apparent both before and after target range berm was built.
- [1997-2002] Dip is present both before and after change in sensor orientation.

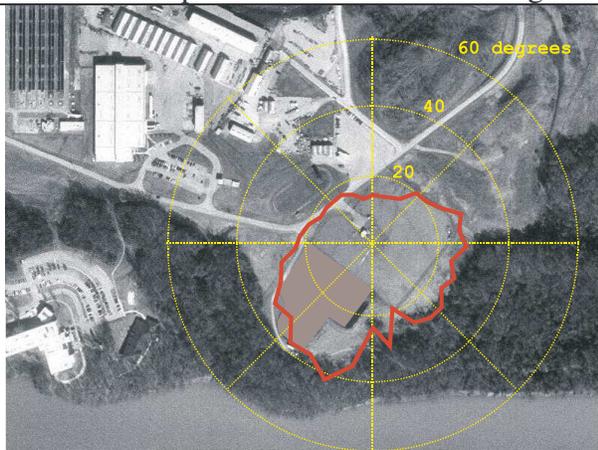
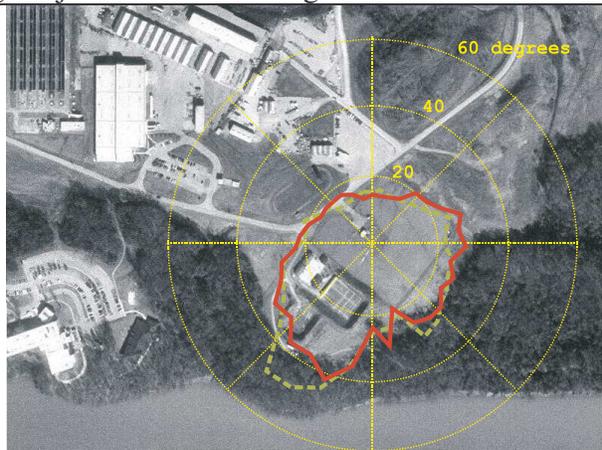
Complete new berms around target range adjacent to meteorological tower site.

— Before berm (1989-1990)

— Before berm (1989-1990)
 - - - - After berm (1992-1993)

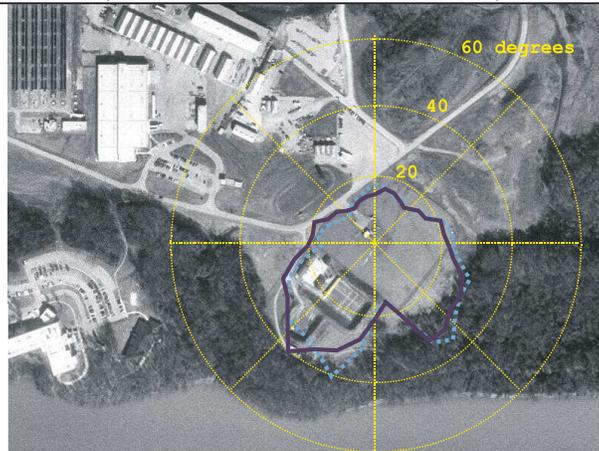
Change orientation of wind sensor mounting arm
(old into WNW, new into ENE).

— Before Re-Orientation (1997-1999) - into WNW
..... After Re-Orientation (2000-2002) - into ENE

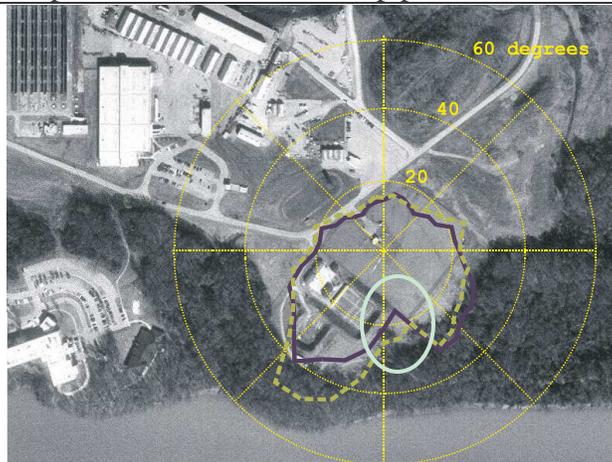
Dip not present in 1992-1993. Dip present in 1997-1999

— 1997-1999
- - - - 1992-1993

Therefore, Sigma-Theta curve changed between 1993 and 1997.

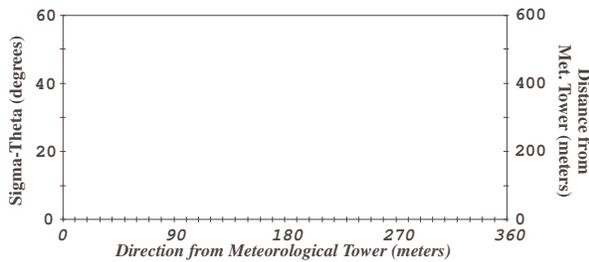
1. Start with blank frame.

*Sigma-Theta scale on left.
Distance scale on right.*

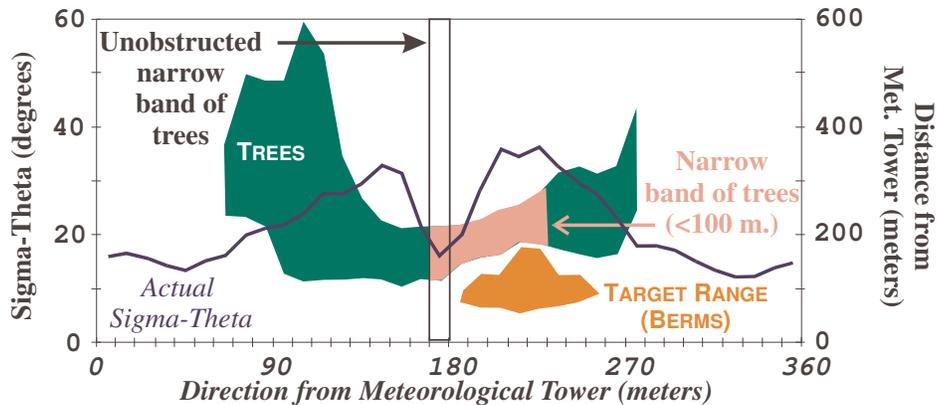
5. Examine portion of curve with dip.

Dip is related to unobstructed narrow band of trees.

The dip in Sigma-Theta curve is due to a narrow band of trees unobstructed by the target range. The dip represents relatively unobstructed wind flow.

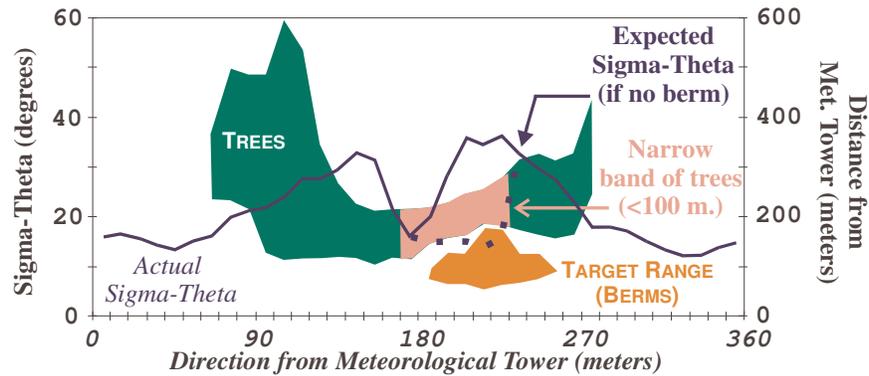
What would curve look like without target range?

Expected Sigma-Theta is estimated based on tree band width.

While the tree band is narrow behind target range, Sigma-Theta values are greater from direction of target range. Consequently, even though it meets obstruction criteria, the berm still impacts measurements.
