Inspection and Replacement of Meteorological Tower Anchors at Callaway Plant.

Presented by Kip Barbour,
System Engineer, Callaway Plant

December 2005 Inspection

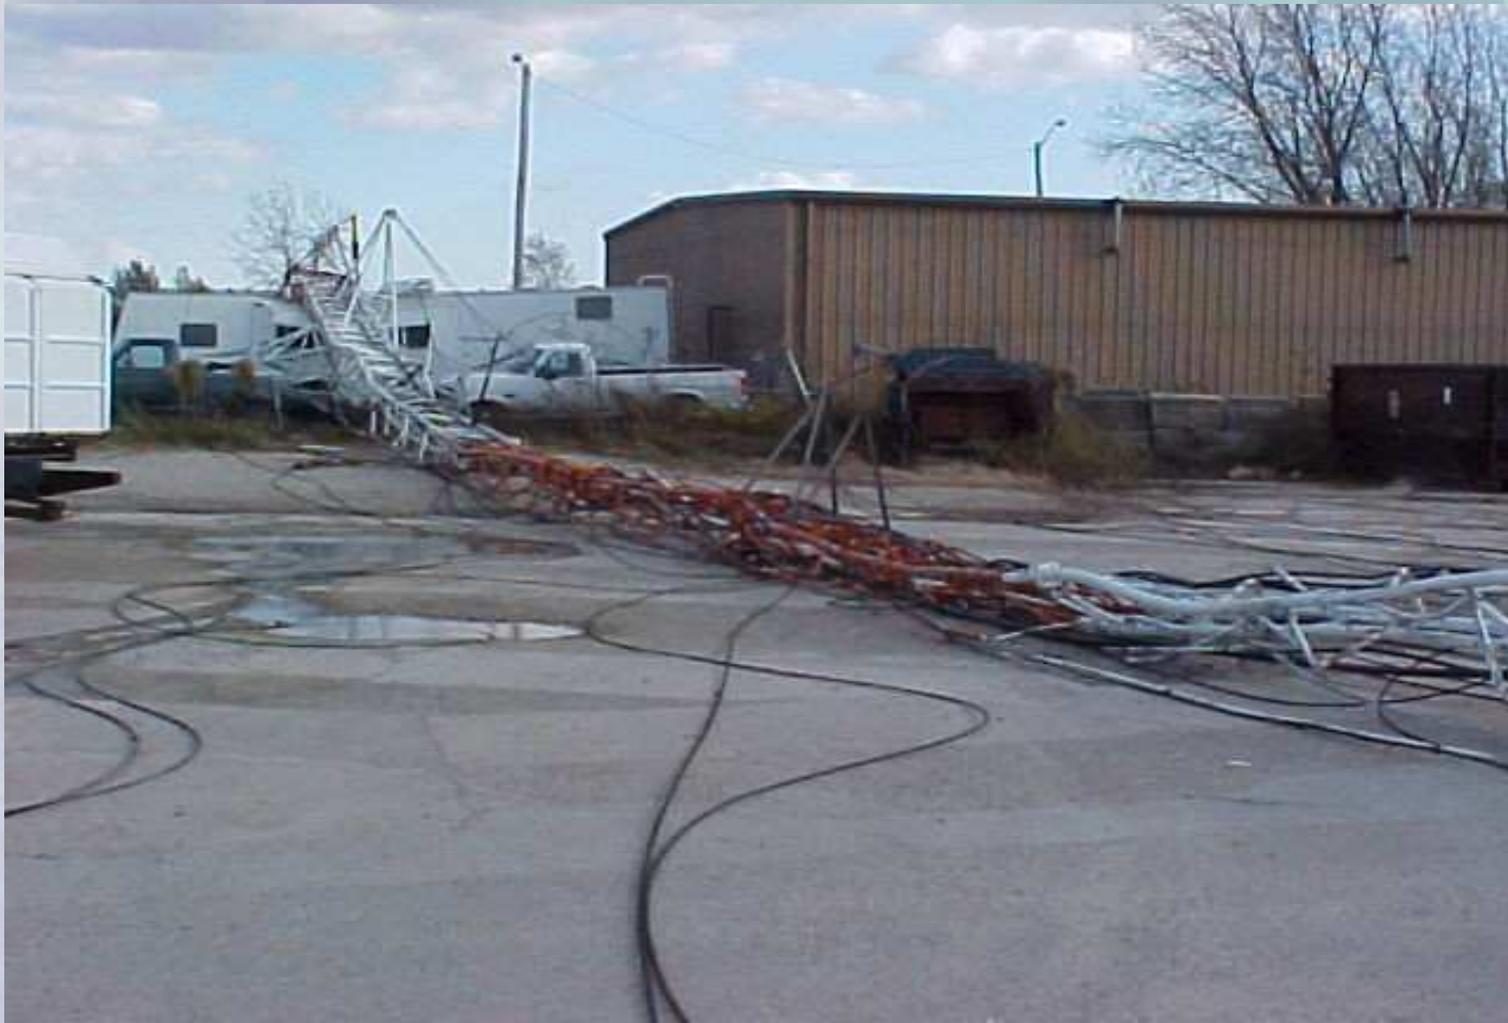
Photo from Matt's Presentation

- To my knowledge, Callaway Plant had never inspected its meteorological tower anchors.
- 2001 NUMUG listserver messages:
 - >Bob Pickwood described the degradation and repair of the anchor rods at Palo Verde.
 - >Paul Fransioli provided information regarding the failure of a meteorological tower at the Sandia National Laboratory (SNL) Solar Test Facility due to degraded anchor rods.
- A NUMUG 2002 Presentation, “Examining Tower Guy Wire Anchor Rods” by Matt Parker illustrated other tower failures.

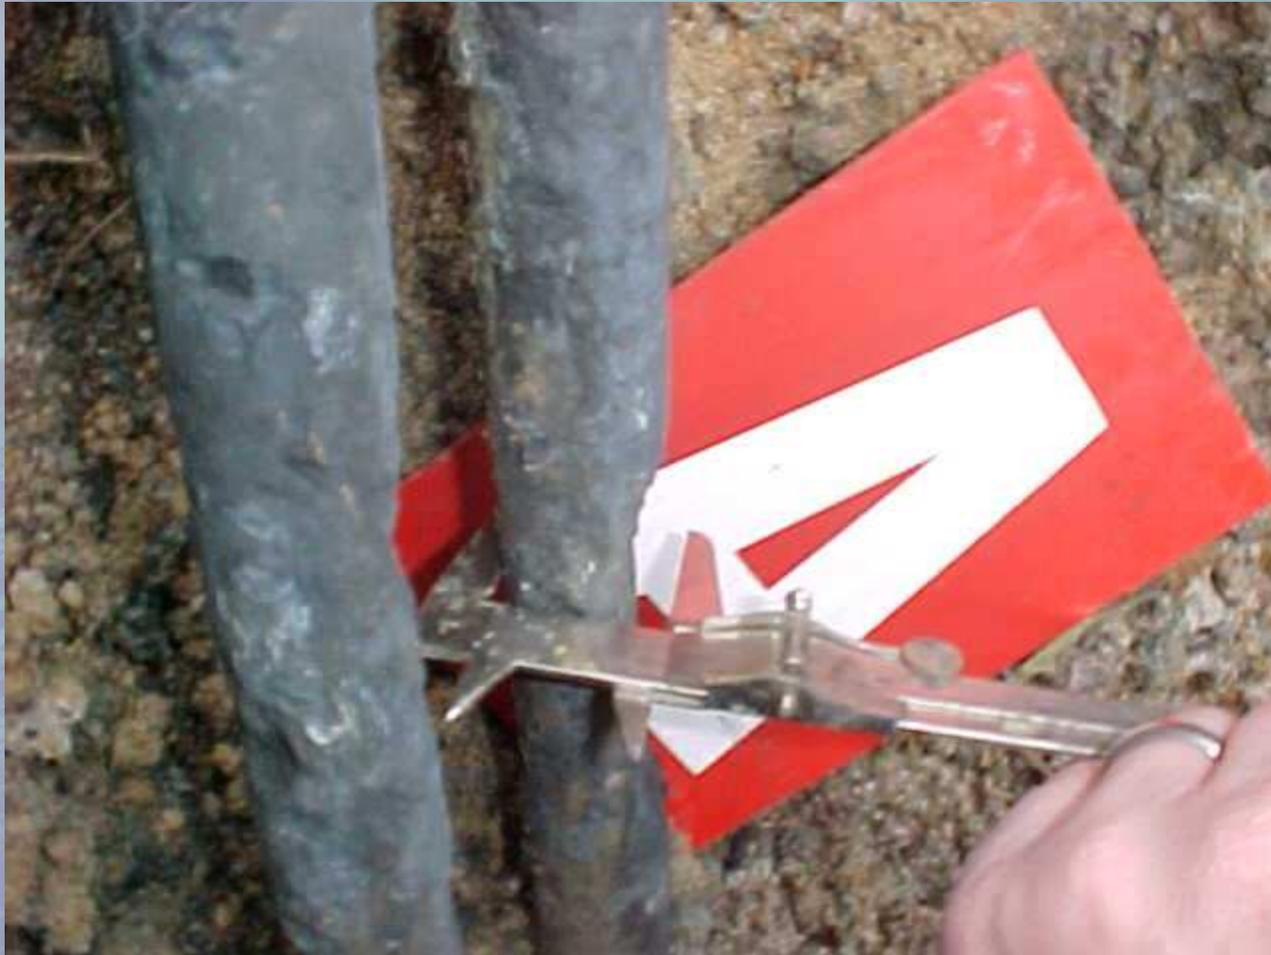
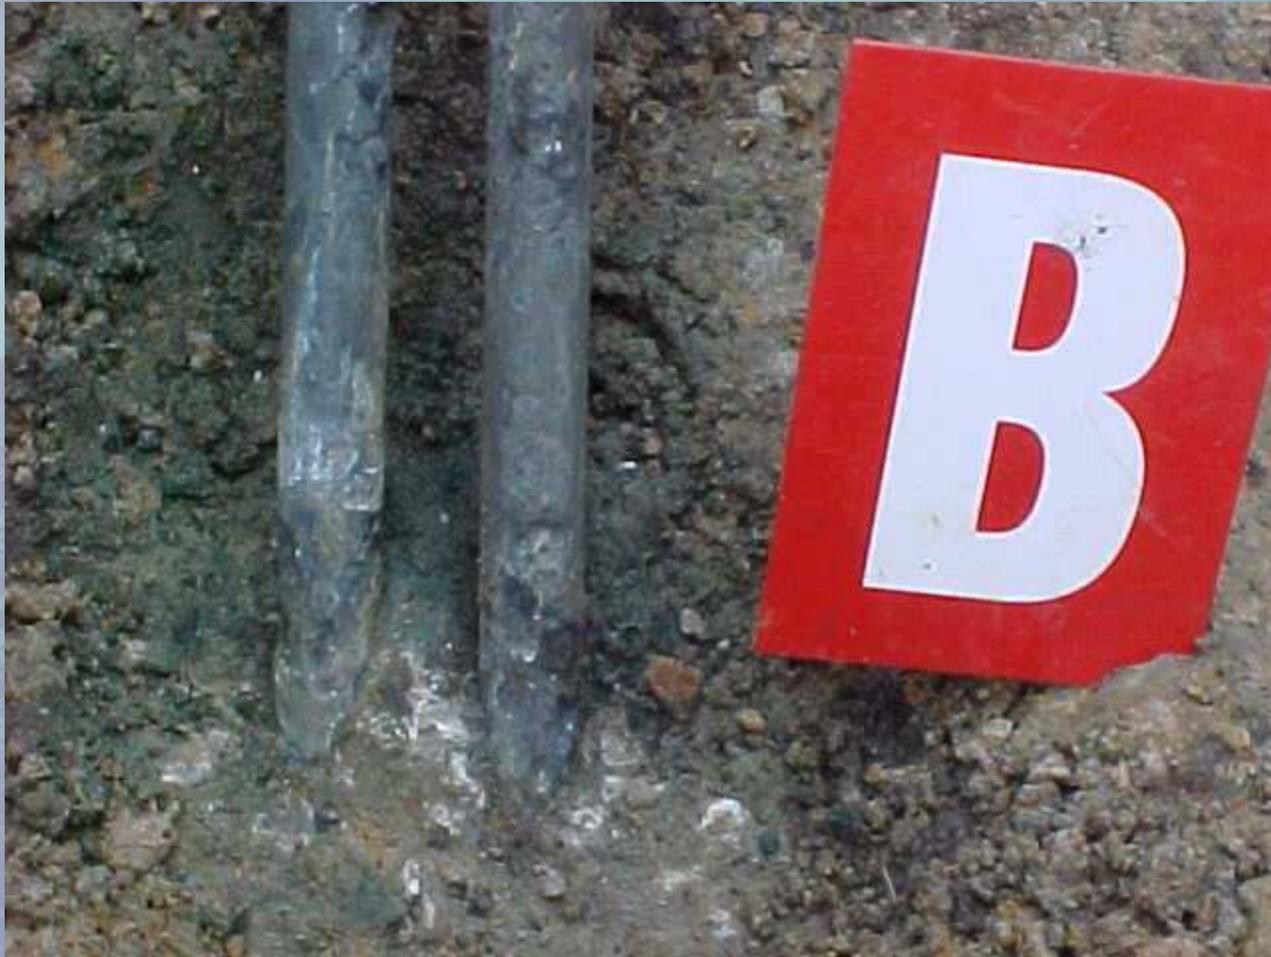
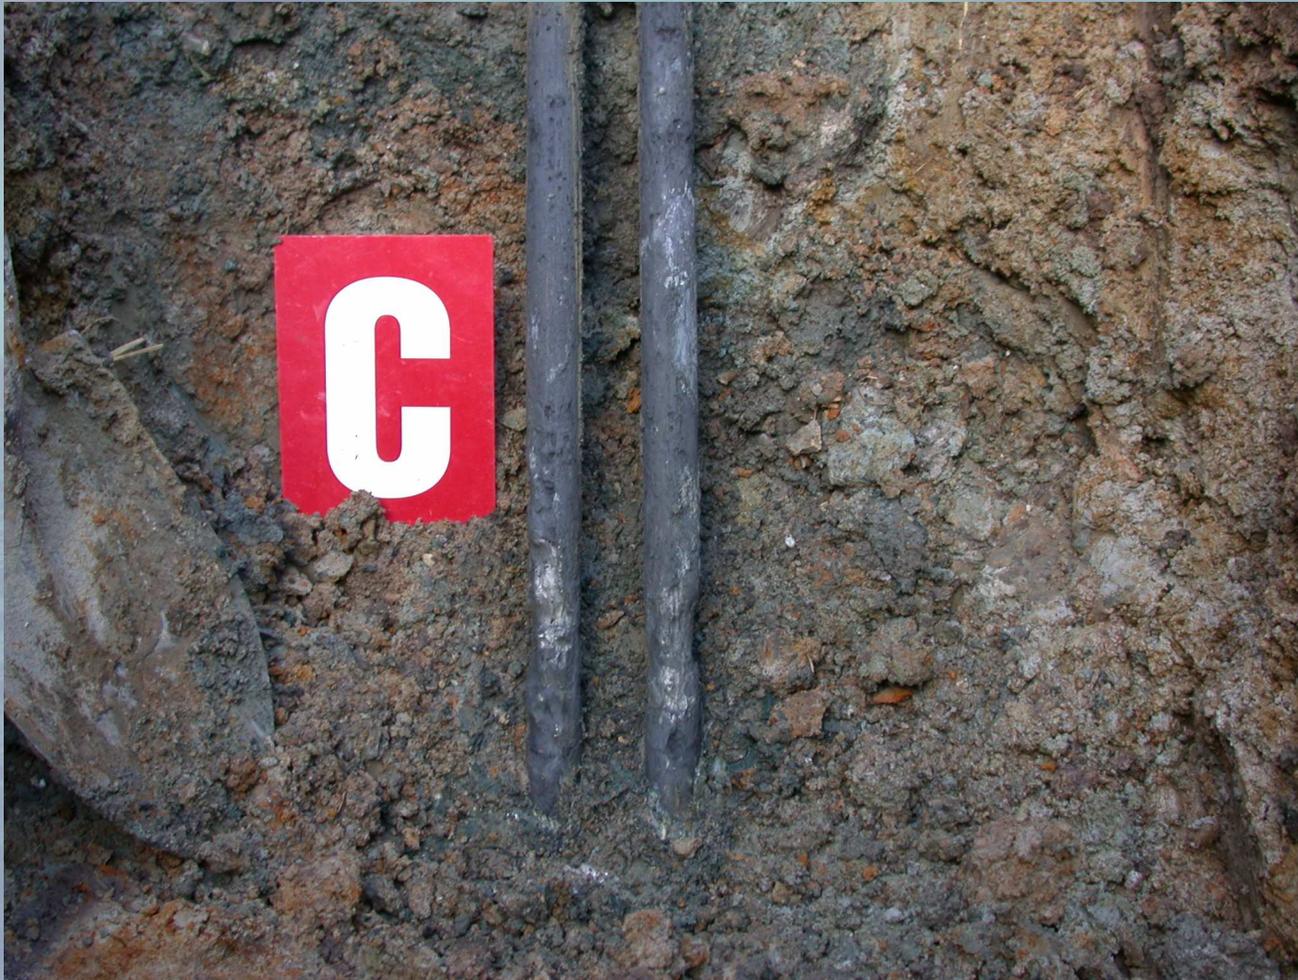
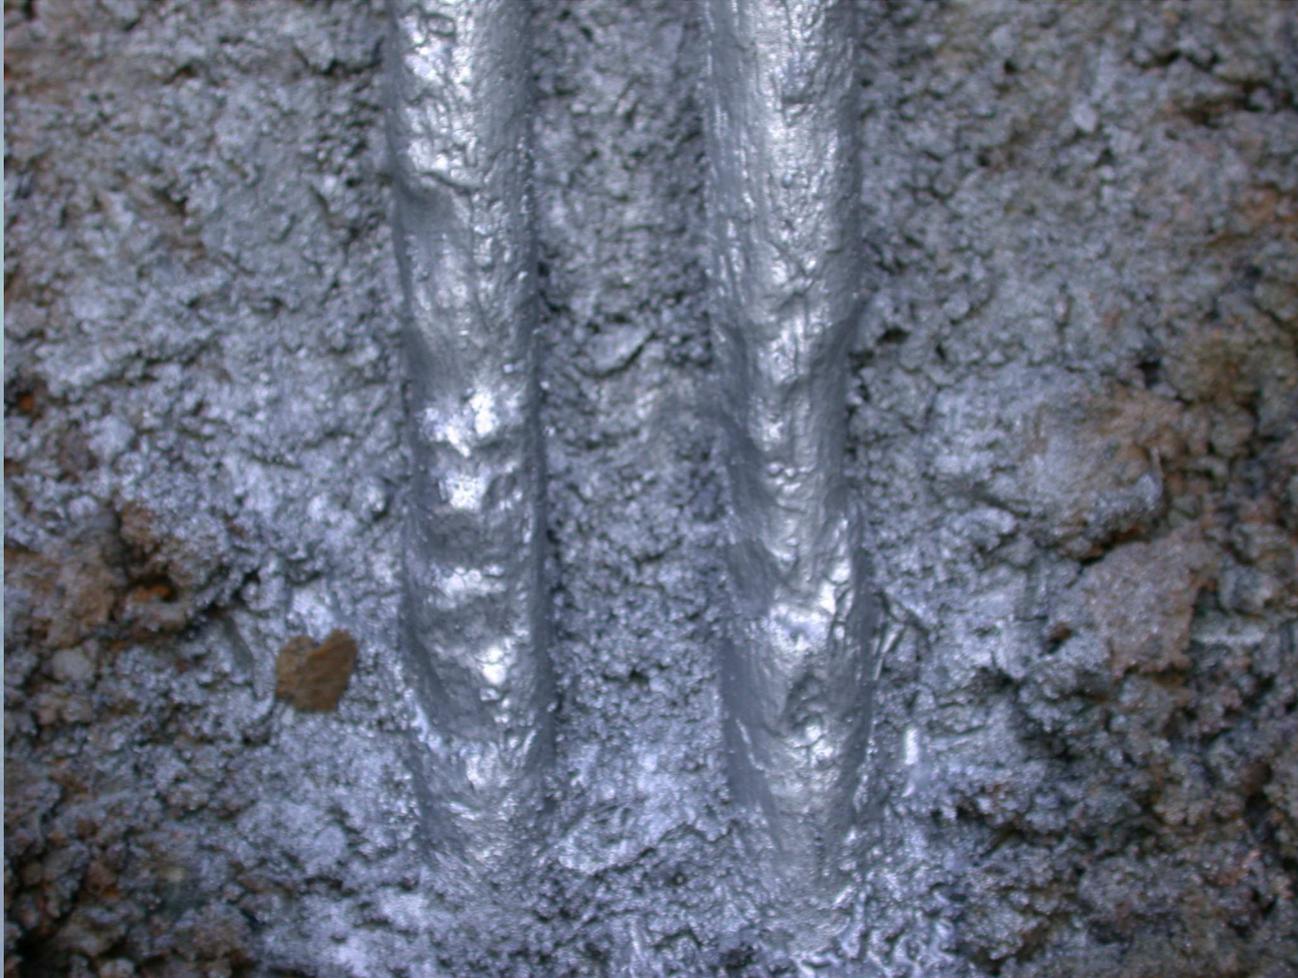
Inspection Results

- The anchors consisted of two 1.25” rods welded to a divider plate.
- Rods were in exceptional condition, except for the last few inches before they entered the concrete slab.
- Substantial degradation was found on several of the rods near the slab, with some rods corroded to 7/8” of material.
- Tower Systems would not climb tower...

- Callaway had to make a decision about how to handle the degradation.
- Even if the remaining material could be evaluated as safe, the degradation extended into the concrete.
- We chose to replace the anchors as soon as possible, and to not allow any climbing until the new anchors were installed.

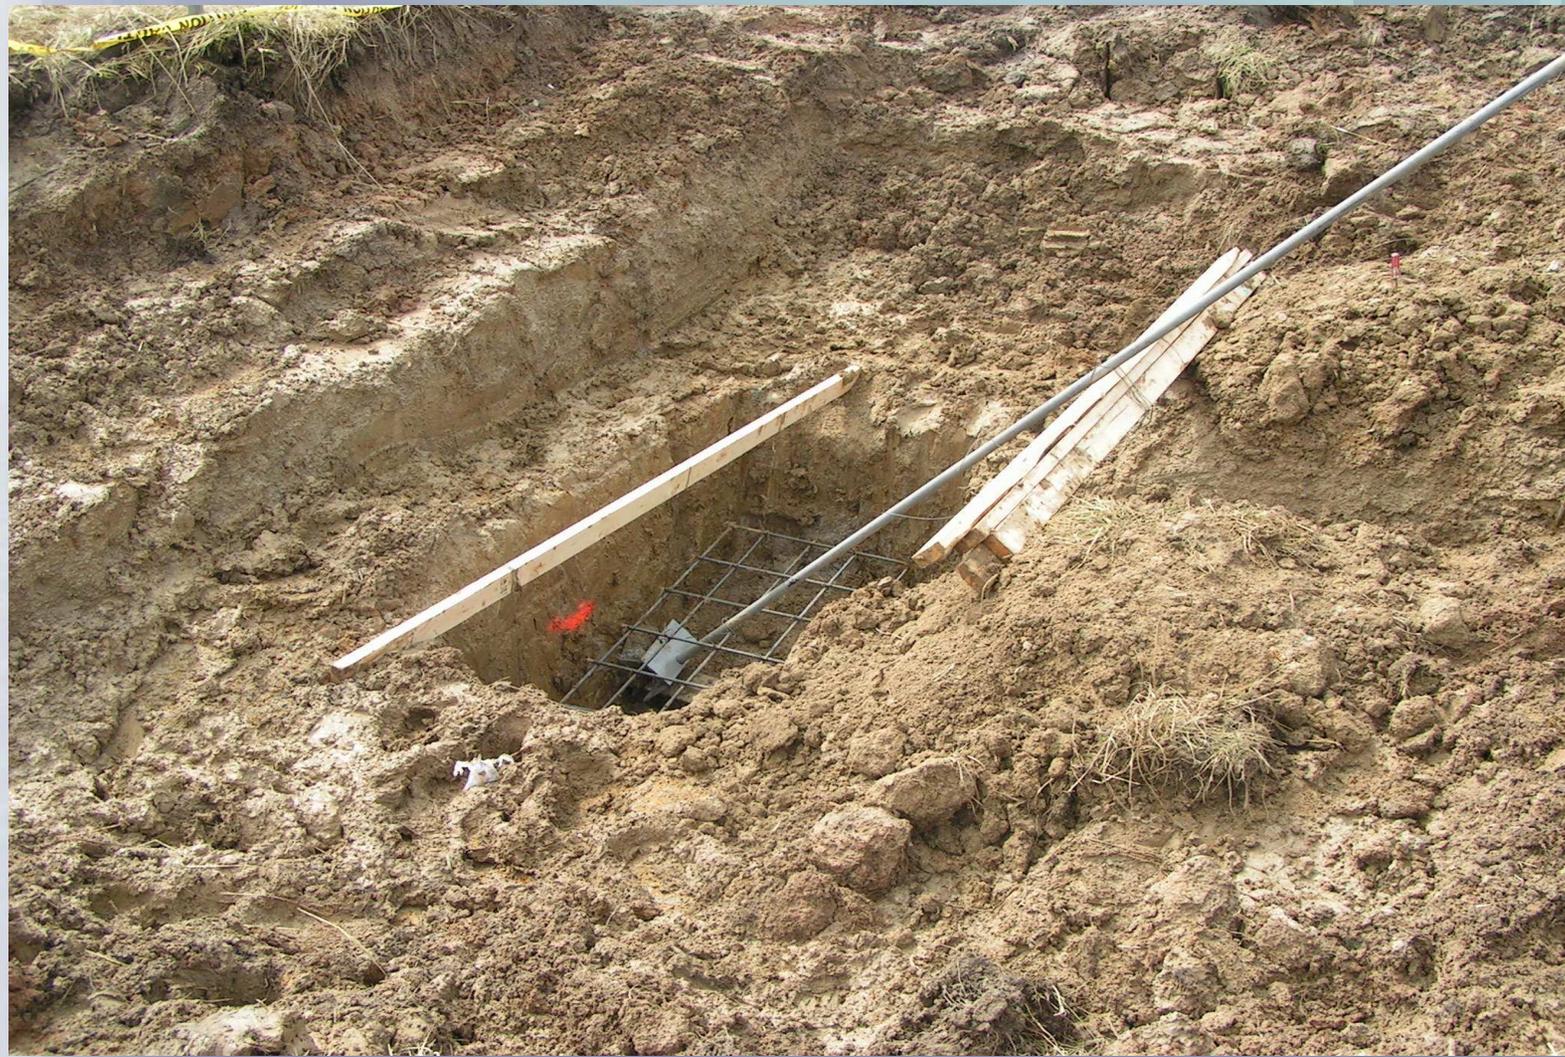
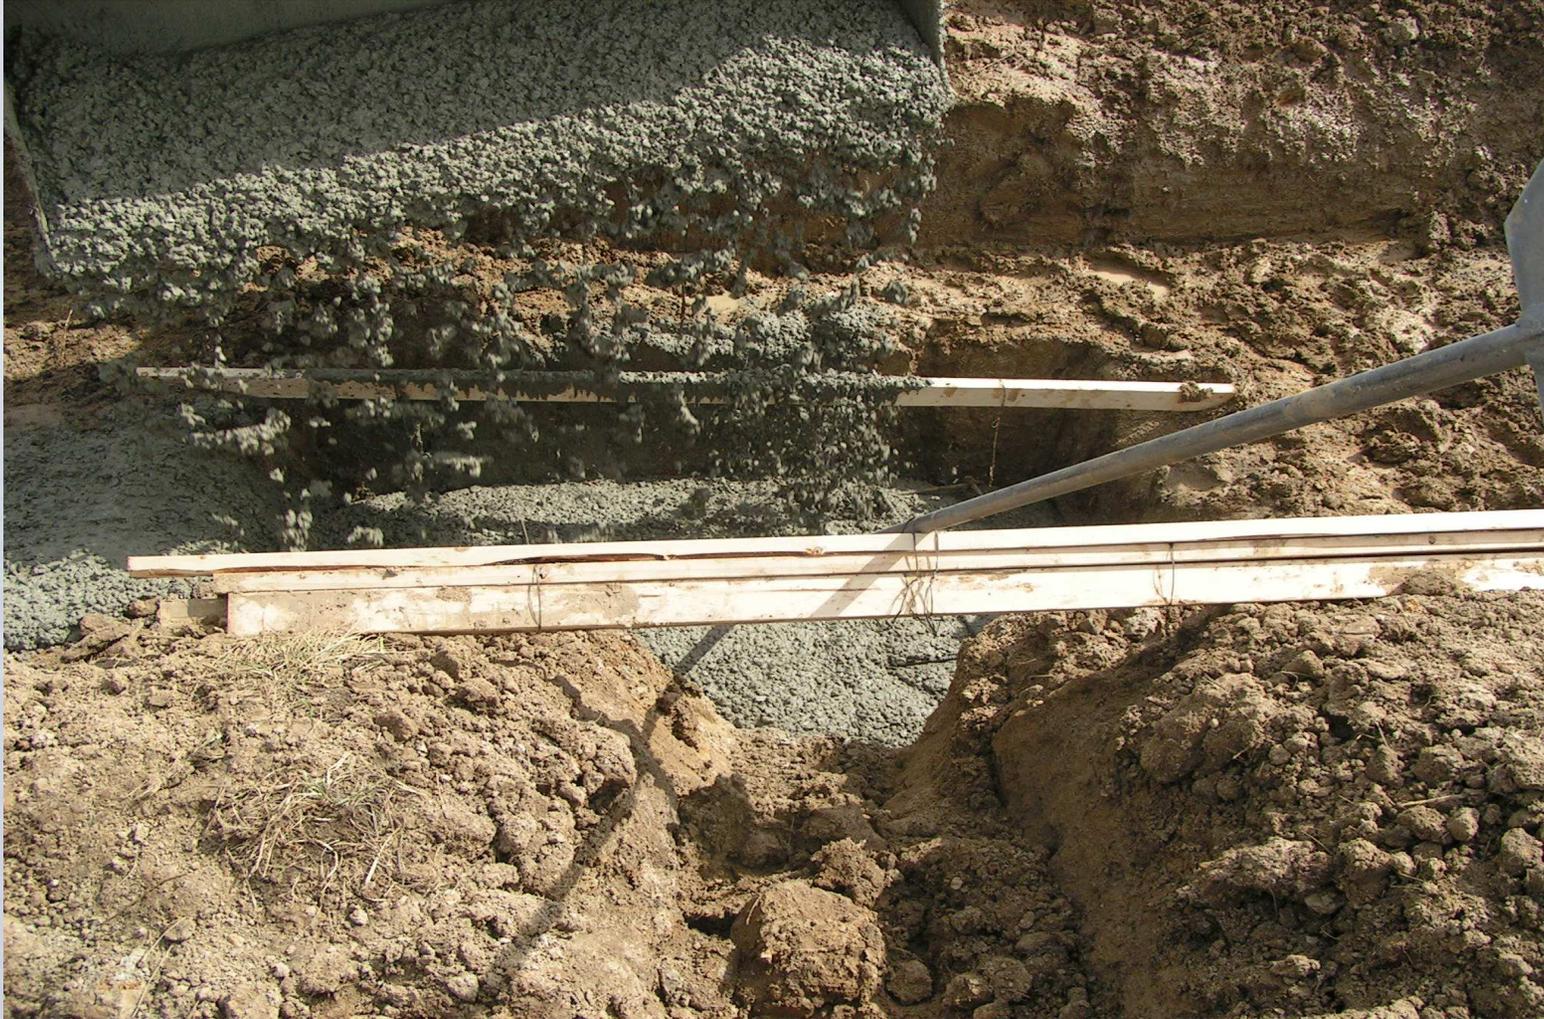
Anchor Replacements

- We could not install the new anchors at the same location as the old anchors.
- Tower Systems provided a civil engineering evaluation of the tower loading in order to move the anchors ~ 50' closer to the tower.
- In March, the protective fence was removed, holes were dug, and new single-rod 1.5" anchors were embedded in concrete slabs.
- The guy wires were then systematically transferred to the new anchor rods.
